**Re: Marathon County Solid Waste Landfill – Bluebird Ridge RDF
2016 Annual Solid Waste Report
WDNR License No. 4228, FID No. 337005680**

Marathon County Solid Waste Department
Bluebird Ridge Recycling & Disposal Facility
2016 ANNUAL REPORT

WDNR License No. 4228
FID 337005680

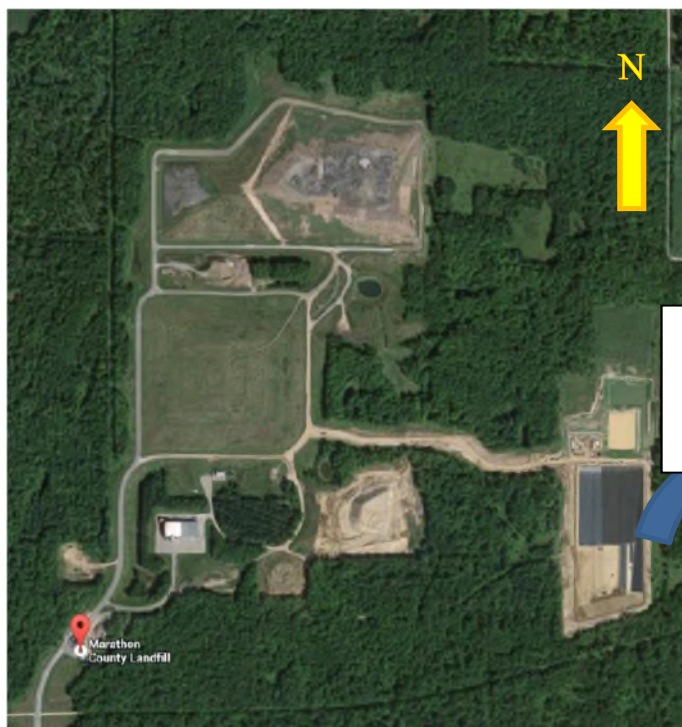
Bluebird Ridge Recycling &
Disposal Facility
(Shown at Construction phase in
September 2013)

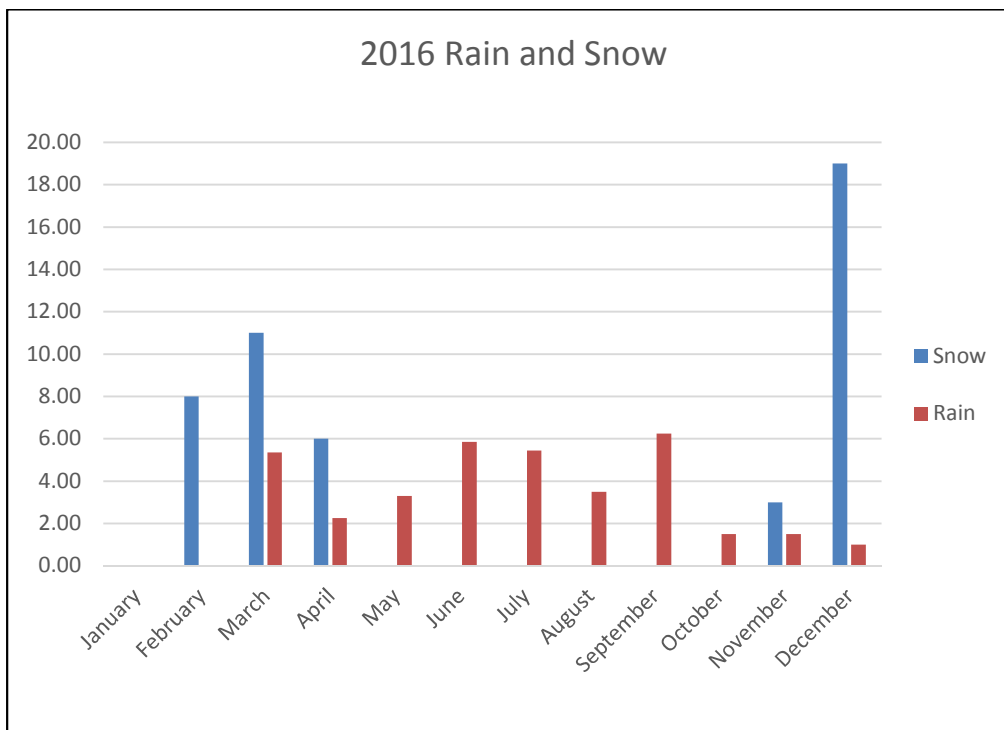
Precipitation:

2016 Precipitation Totals			
Month	Snow (inches)	Rain (inches)	Liquid Precipitation* (inches)
January			0.00
February	8.00		0.80
March	11.00	5.35	6.45
April	6.00	2.25	2.85
May		3.30	3.30
June		5.85	5.85
July		5.45	5.45
August		3.50	3.50
September		6.25	6.25
October		1.50	1.50
November	3.00	1.50	1.80
December	19.00	1.00	2.90
Total	47.00	35.95	40.65
