Re: Marathon County Solid Waste Landfill – Area B Landfill 2018 Annual Solid Waste Report WDNR License No. 3338, FID No. 737092730

Marathon County Solid Waste Department <u>Area B Landfill</u> 2018 ANNUAL REPORT

WDNR License No. 3338 FID 737092730

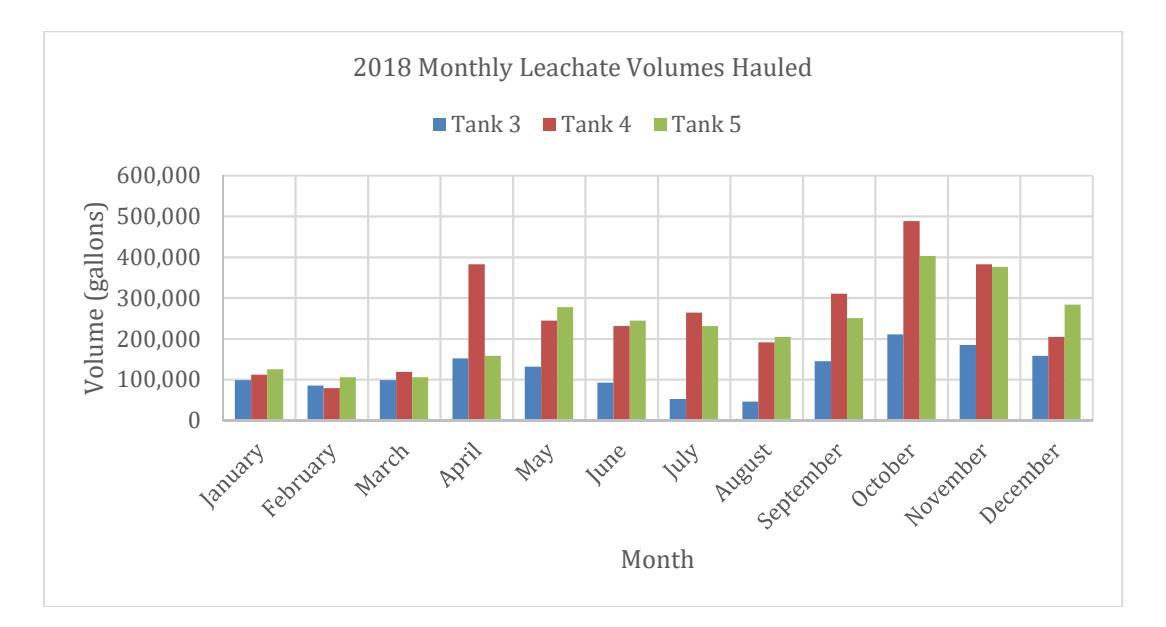
Total volume (gallons) of leachate collected/transported/treated in 2018 is as follows:

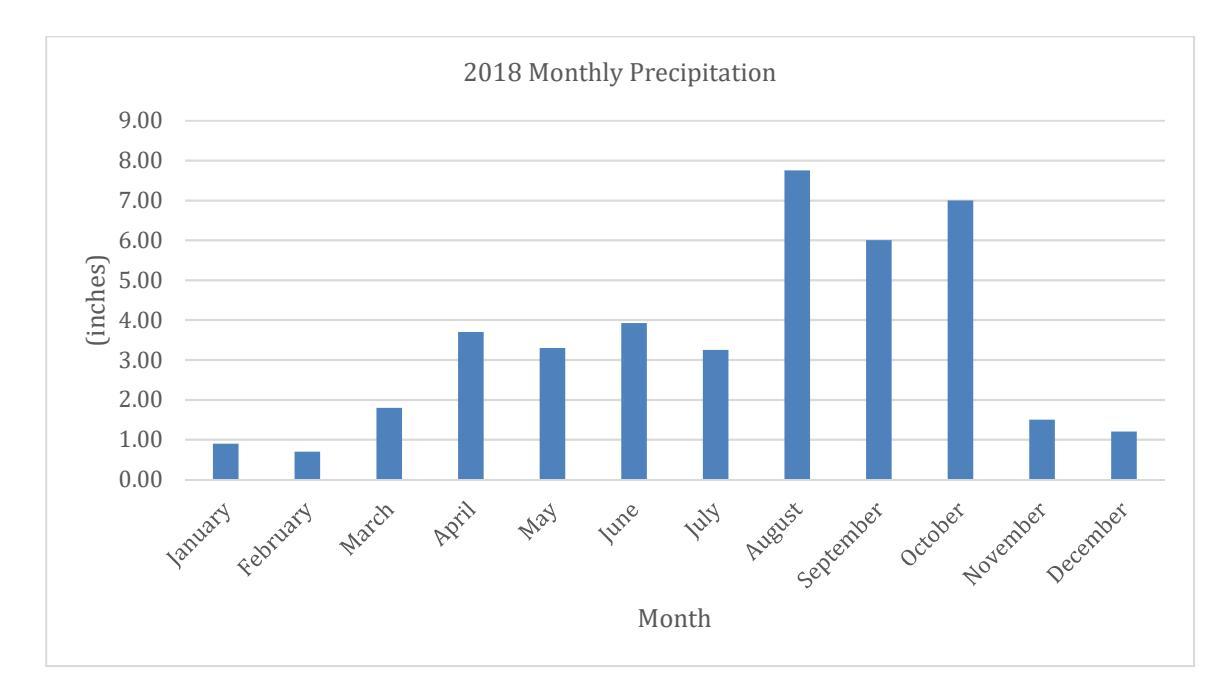
Precipitation:

2018 Precipitation Totals						
	Snow	Rain	Precipitation*			
Month	(inches)	(inches)	(inches)			
January	9.00		0.90			
February	7.00		0.70			
March	12.00	0.60	1.80			
April	32.00	0.50	3.70			
May		3.30	3.30			
June		3.92	3.92			
July		3.25	3.25			
August		7.75	7.75			
September		6.00	6.00			
October		7.00	7.00			
November		1.50	1.50			
December	2.00	1.00	1.20			
Total			41.02

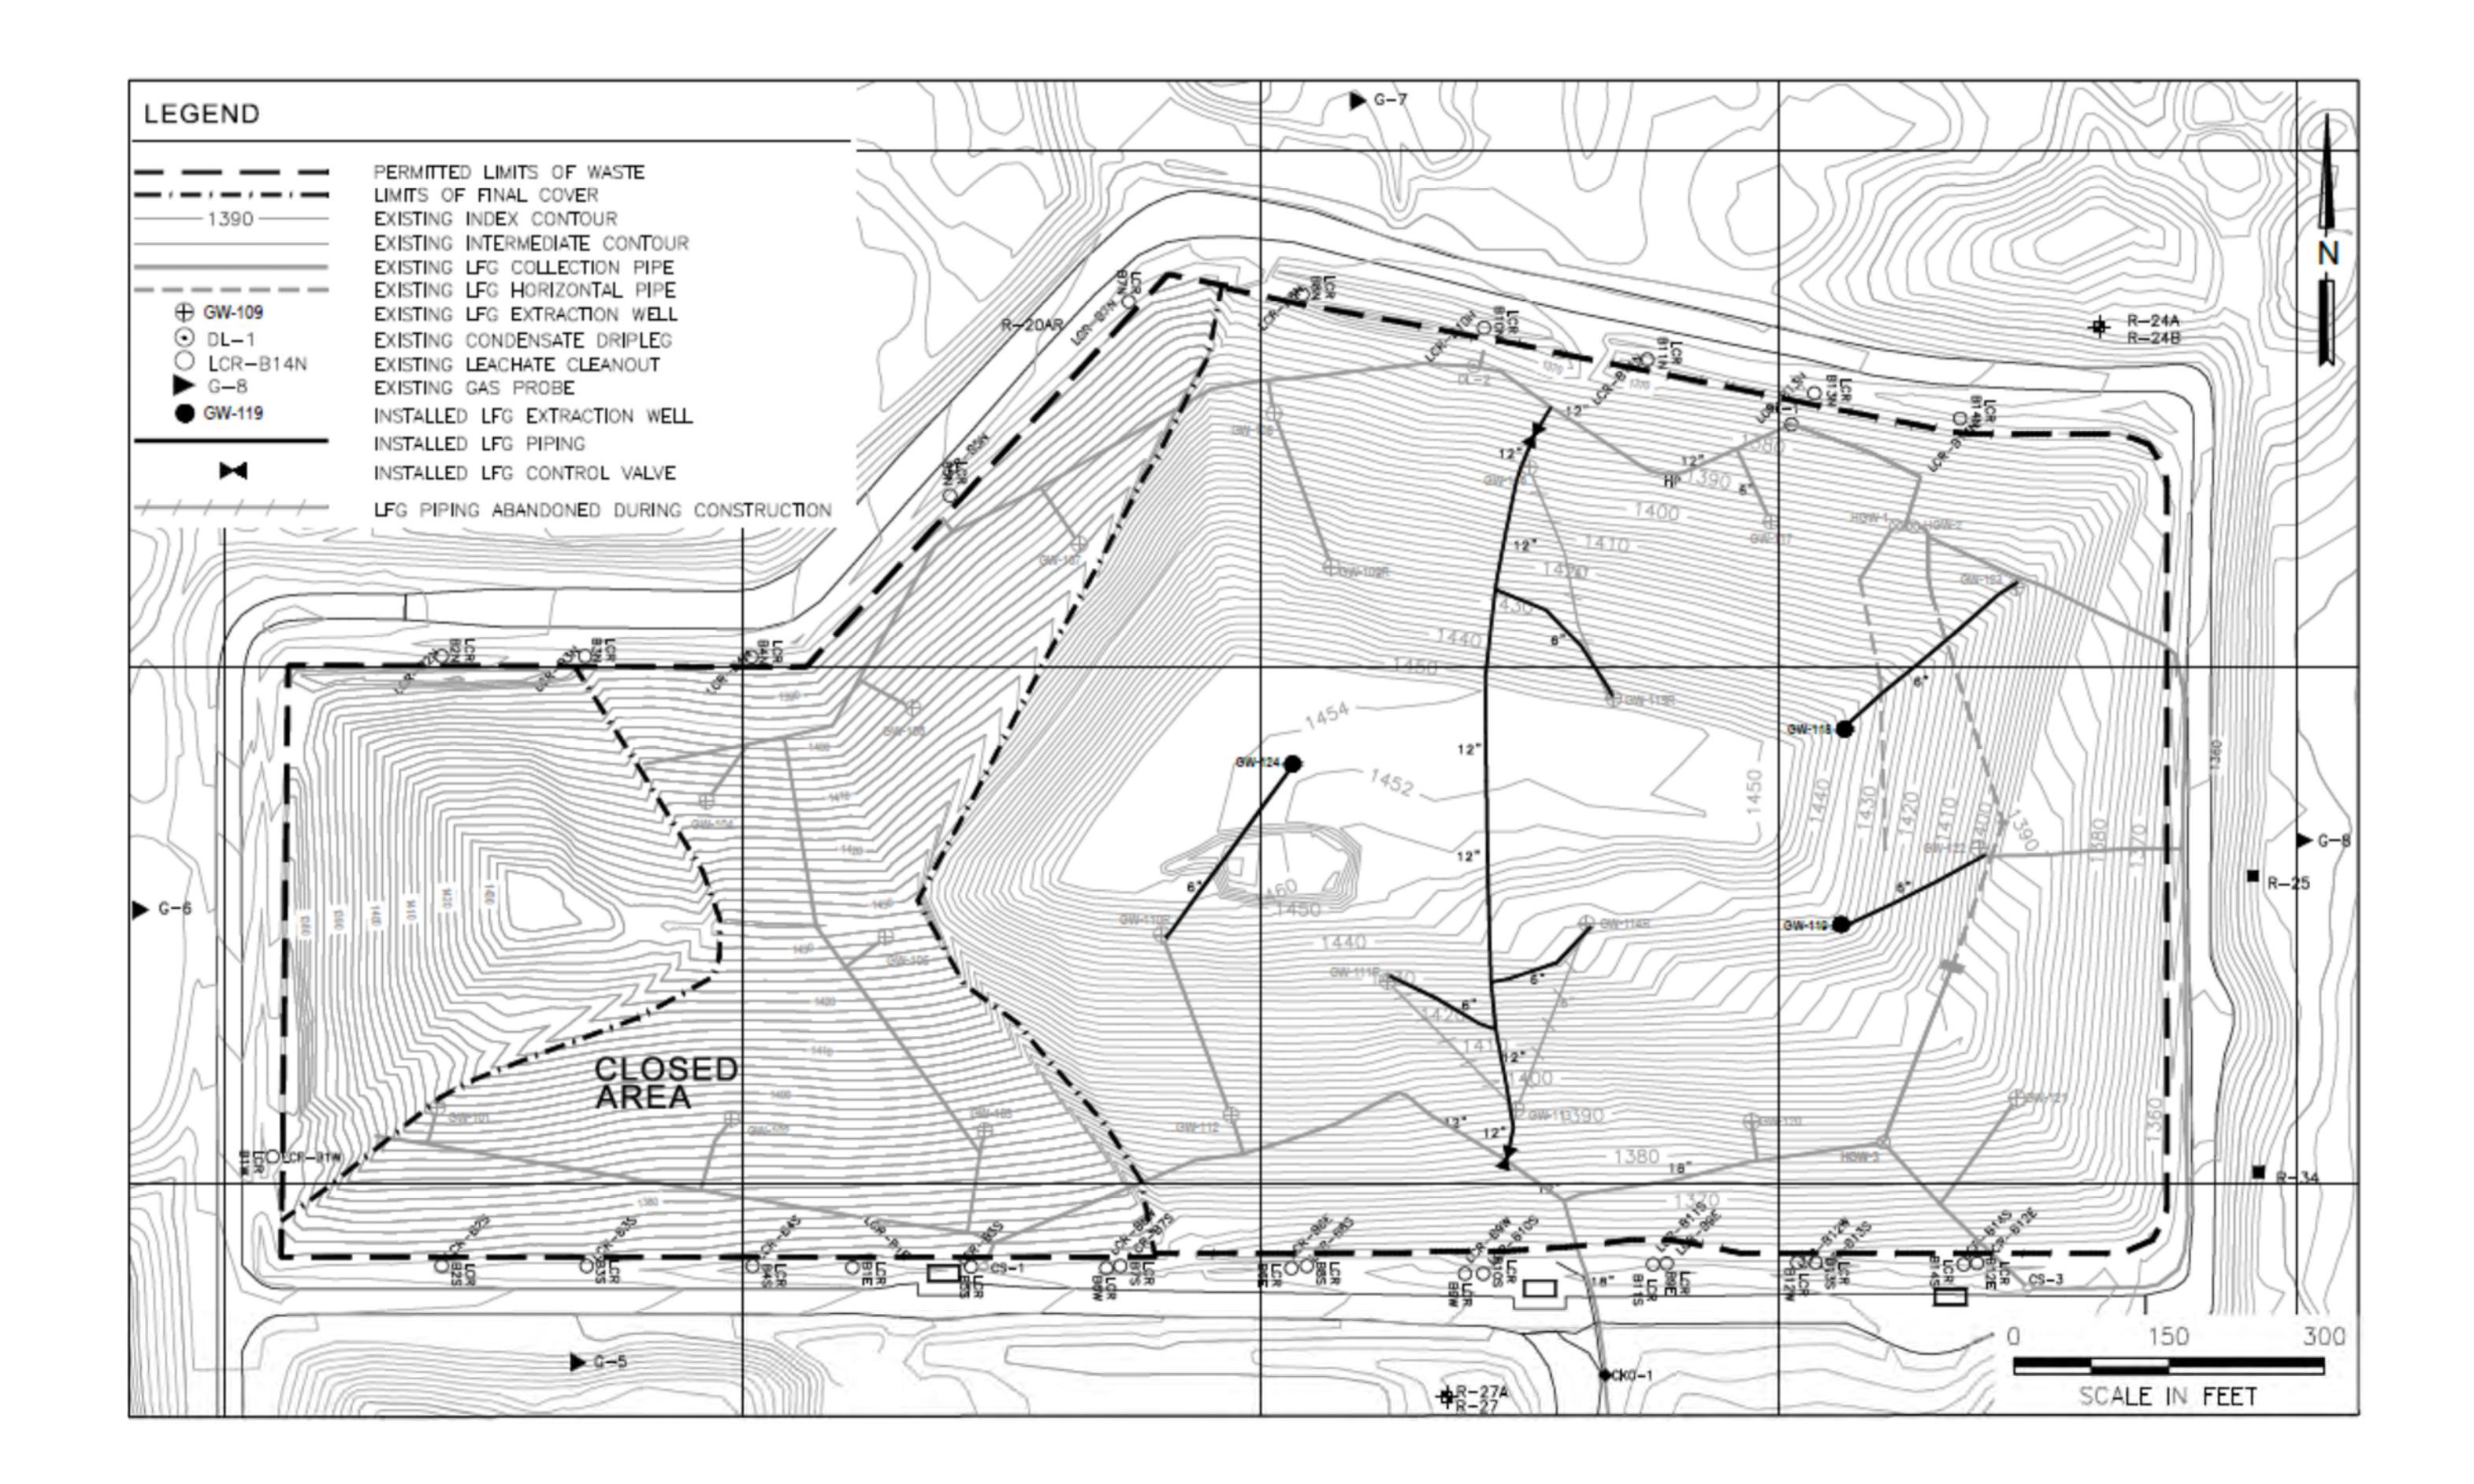
AREA B GAS COLLECTION AND CONTROL SYSTEM MAP

The gas wells located in Area B consist of vertical and horizontal gas extraction wells, connected via a sub-header system within the footprint of the landfill. The landfill gas extracted from the landfill is transferred to the on-site landfill gas recovery building (located south of the Area A Landfill) via a header pipe to a landfill gas to energy plant or to a flare. Vacuum applied to the wellfield is regulated by the variable frequency drive (VFD) blower station that controls the gas collection and control system (GCCS). A map of the Area B GCCS, following improvements made in 2015, is provided in Attachment A.
