Marathon County Solid Waste Department Bluebird Ridge Recycling & Disposal Facility 2021 ANNUAL REPORT

WDNR License No. 4228 FID 337005680

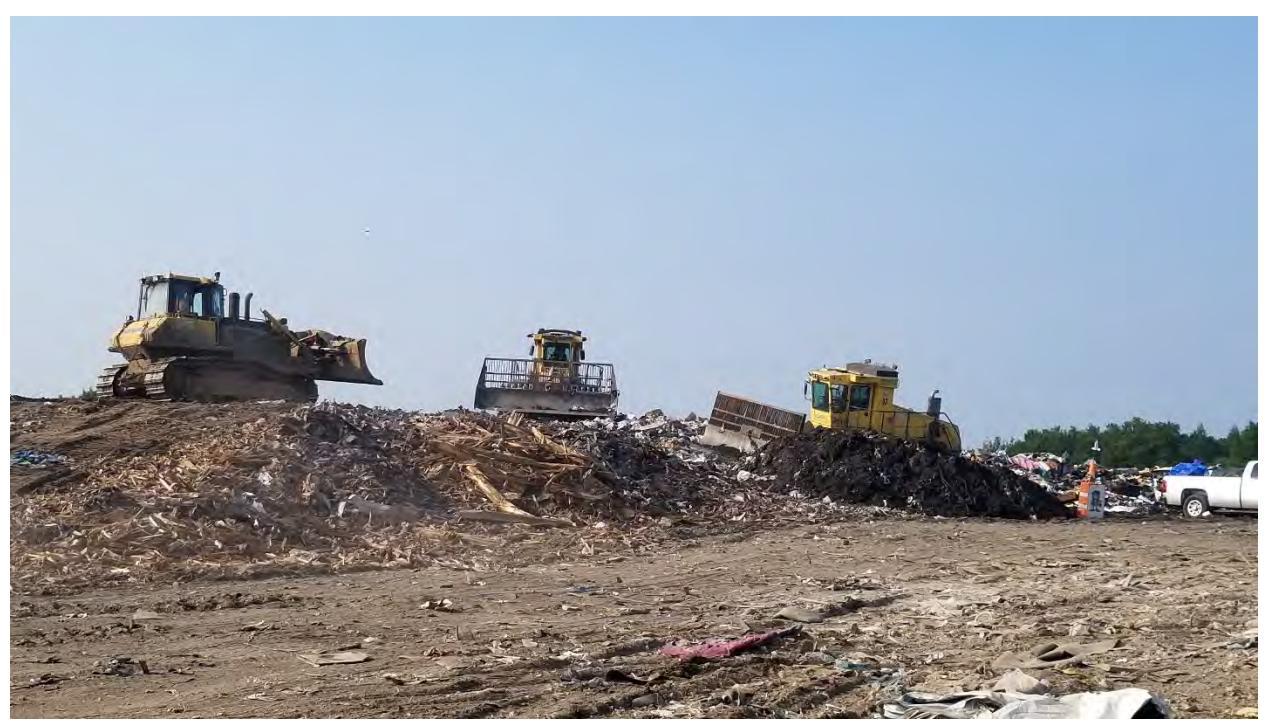
Spring 2021 – access road construction

In 2021, all 5 phases of BRRDF were brought up to an even elevation, and continuous lifts were built across all phases. A new access road was installed up the northern section of the site, and wraps around the east portion as it serpentines up the landfill at a 6% slope. 2021 consisted of a large amount of outside slope filling as the site continued to raise in elevation.

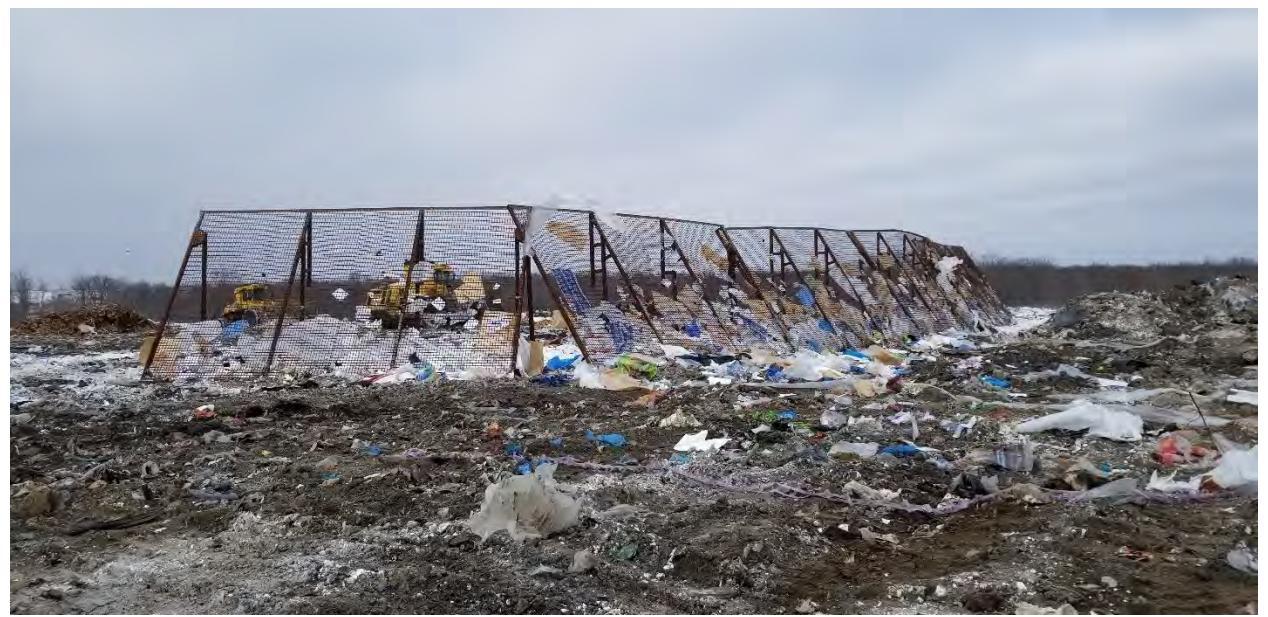
Litter control fencing utilized near active areas – fall 2021

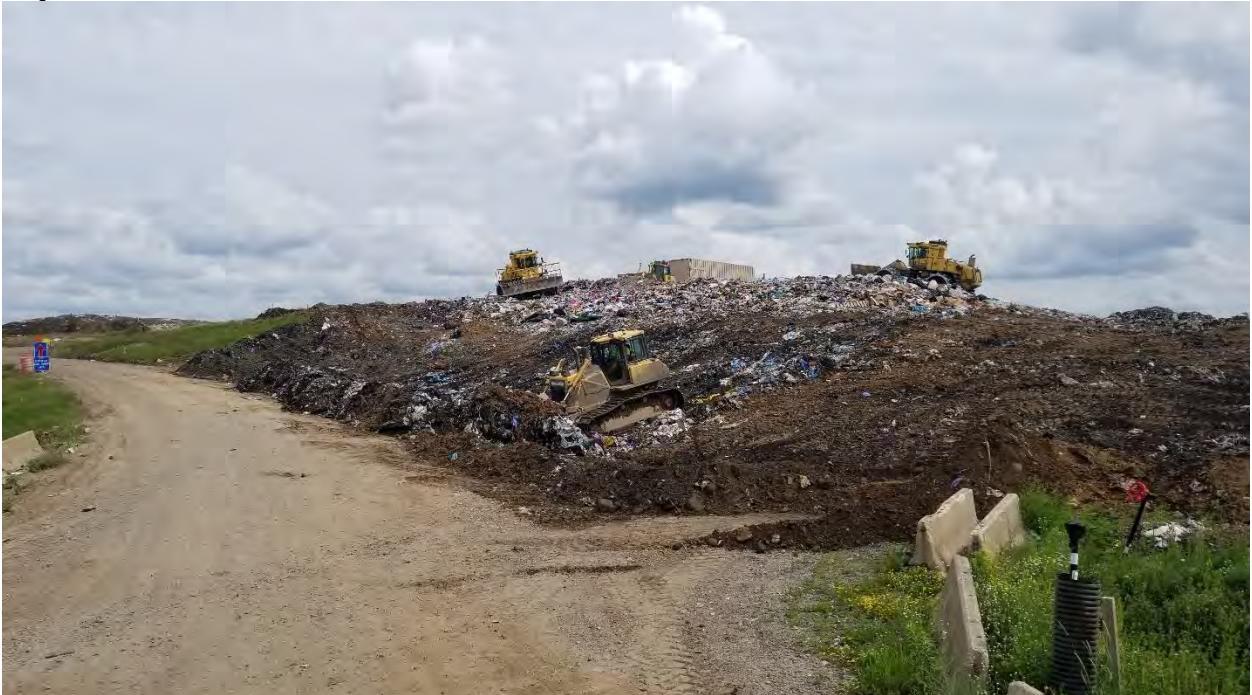
Filling operations along north slope of BRRDF.

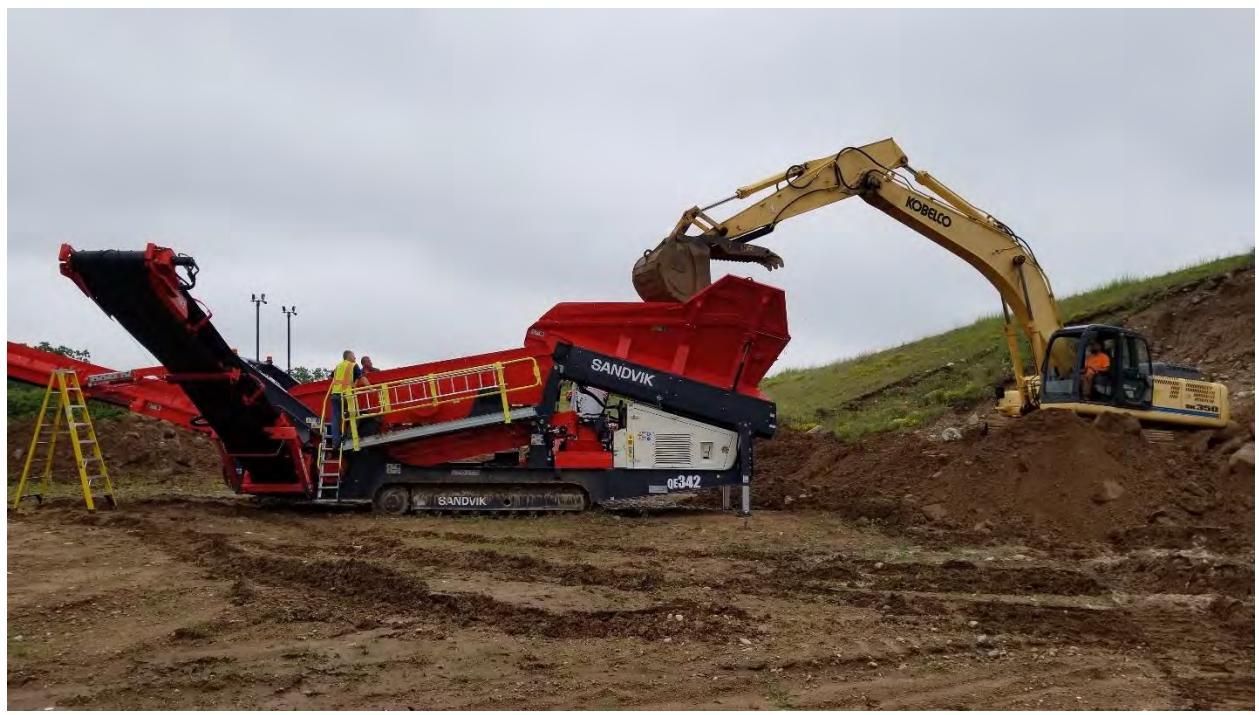
Screening soil for intermediate cover use

Intermediate cover consisted of screening and hauling large quantities of material. Photos below detail the work involved to adequately install intermediate cover across large portions of exterior slopes.

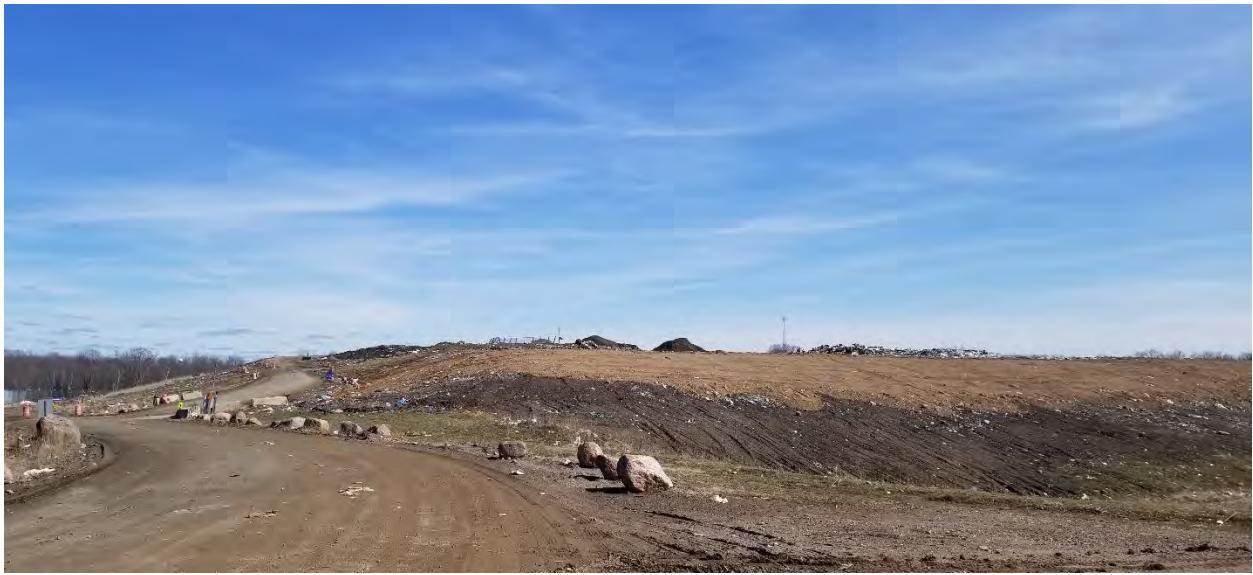
Soil placed on North and West slopes

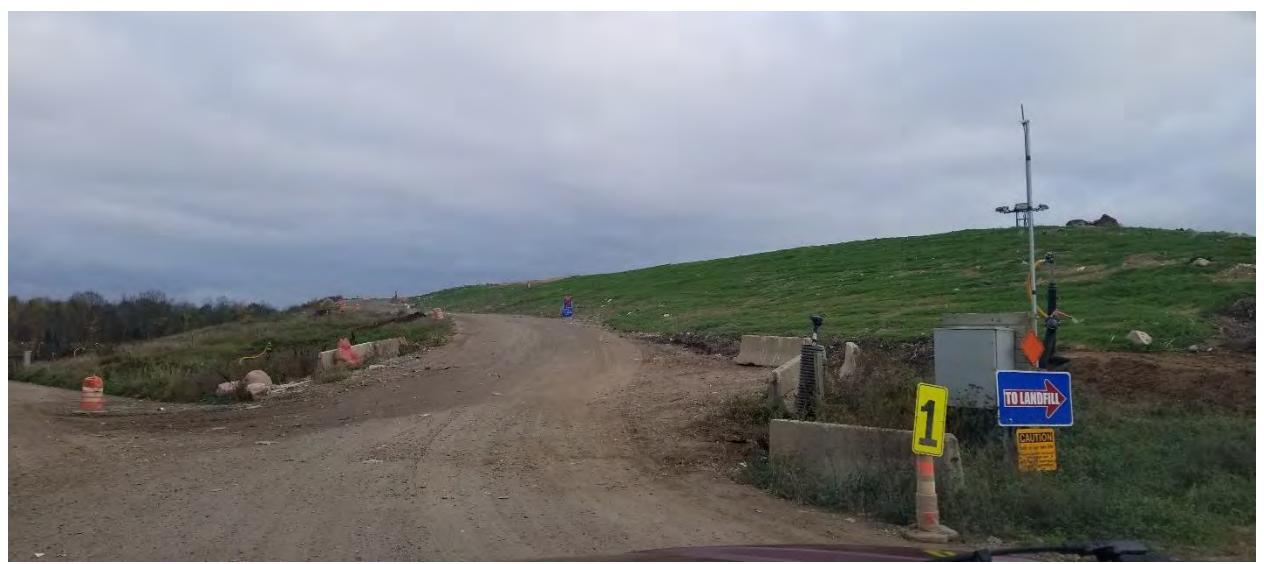
Result of north slope after intermediate cover, compost, and seeding

- Placed and seeded approximately 6 acres of intermediate cover for erosion control.
- Gas system penetration points filled with bentonite and capped with wellbore seals.

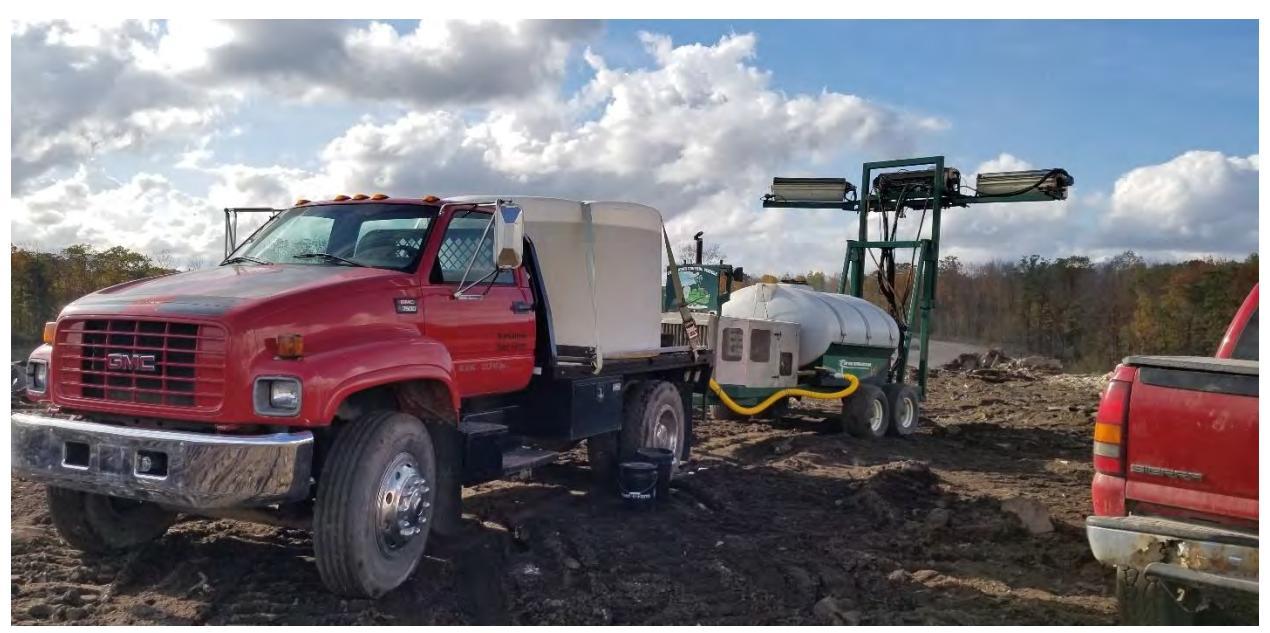
Misting system used near active areas to reduce odor.

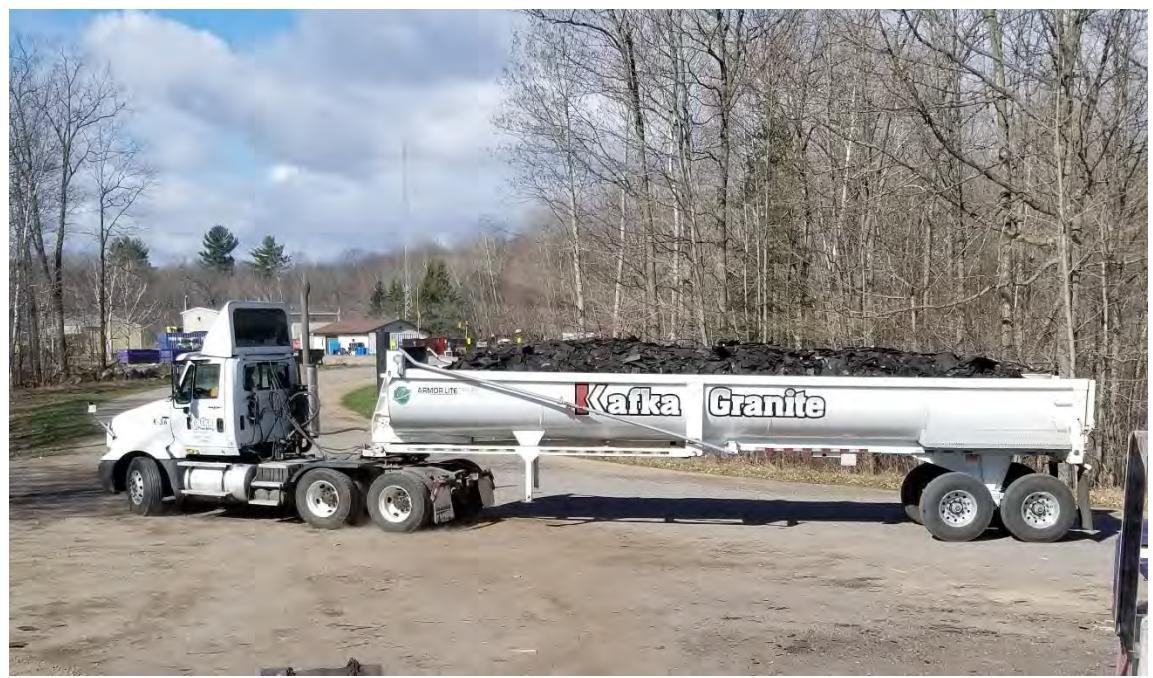
Recycling shingles hauled off site by Kafka Granite

In 2021, the shingle recycling program diverted 809 tons of shingles from landfill disposal. All shingles were taken to Kafka Granite in Mosinee, Wisconsin, where they were ground up and nails were removed via magnet. Ground shingles were mixed with asphalt.

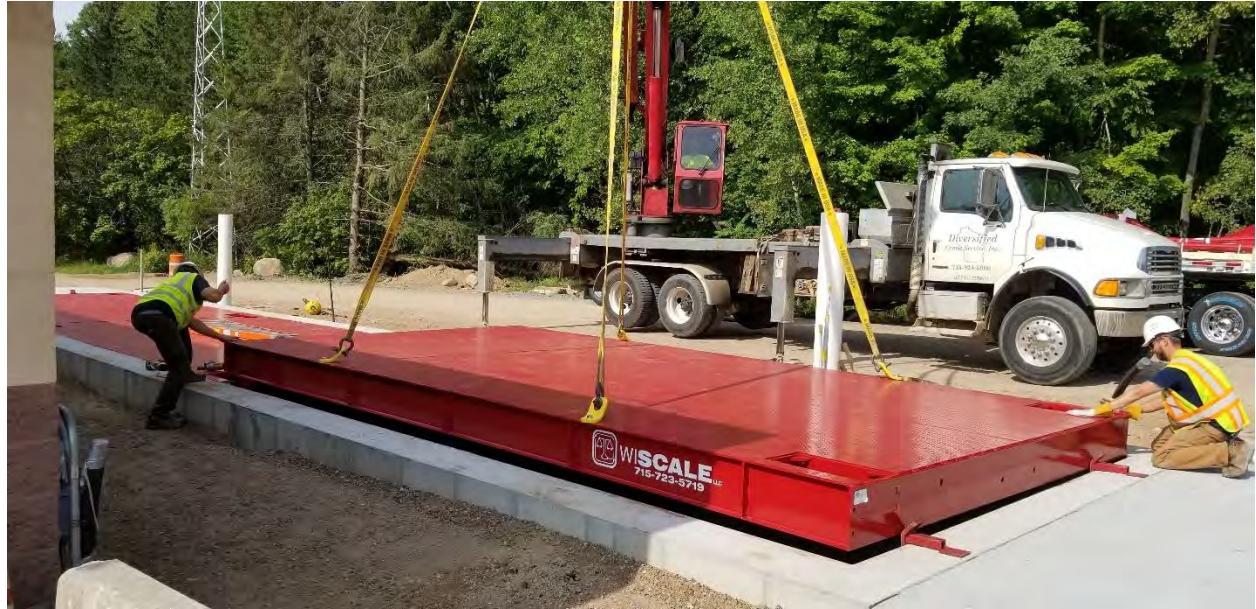
Scale installation

The facility also installed a new scale as an upgrade to the site's operations. An outbound scale was installed on the west side of the office building. WiScale was the installer, and the project went well. The site now uses 2 scale, one inbound and one outbound.

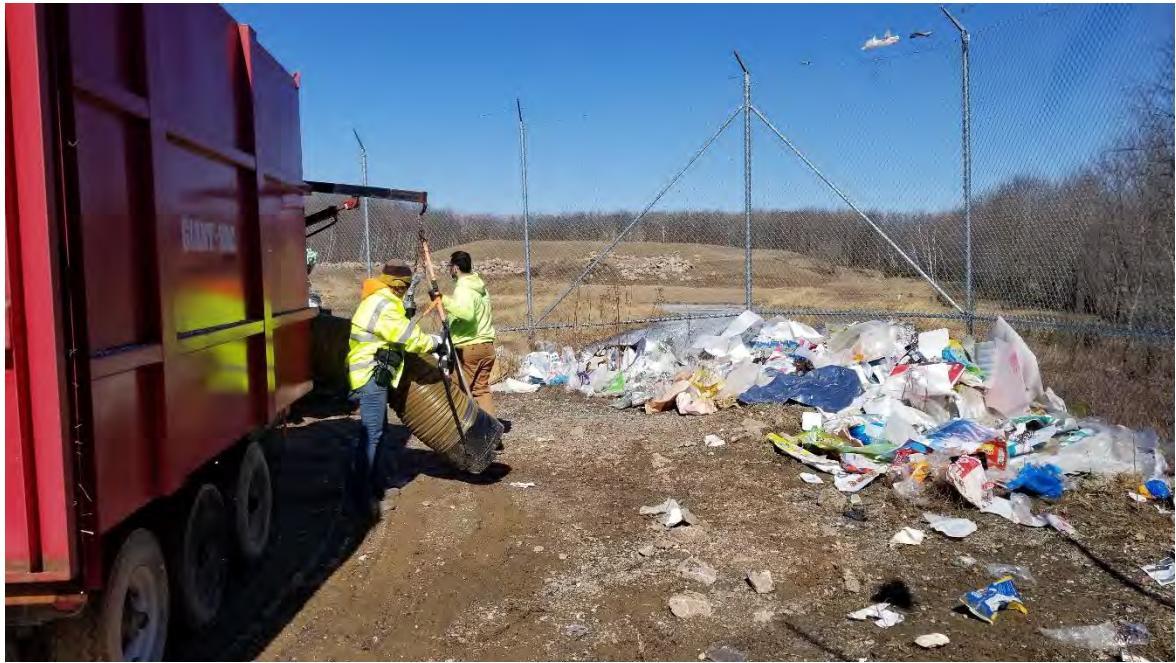
Wind blown litter cleanup process March 2021.

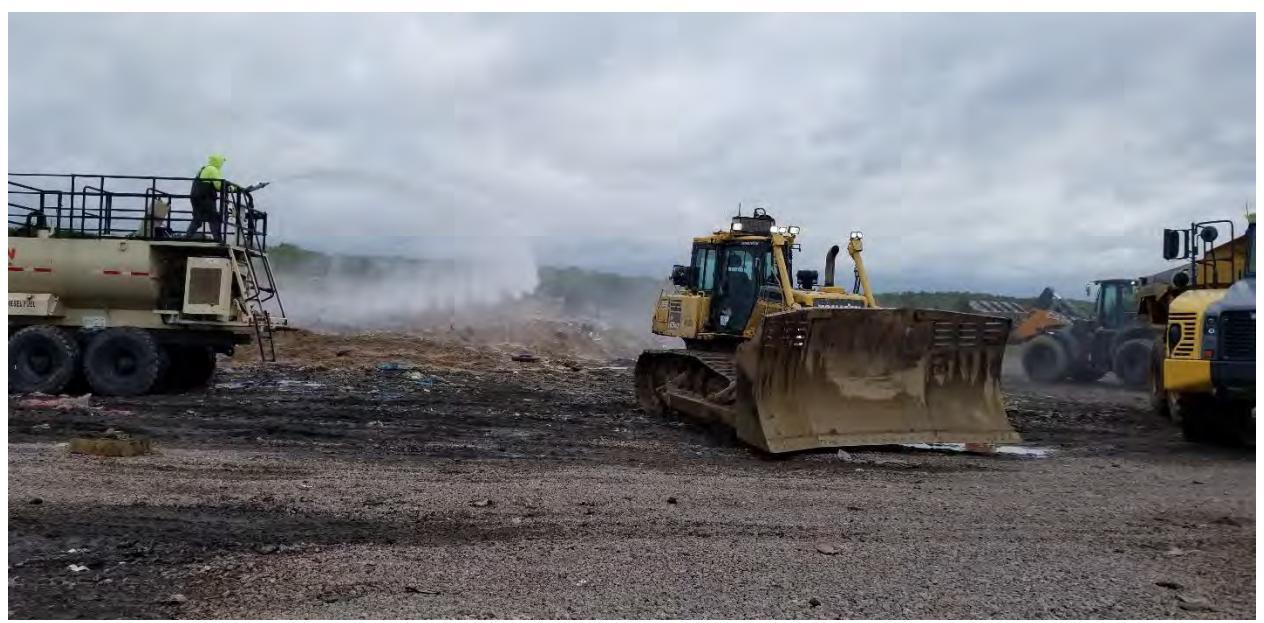
In September of 2021, a landfill fire occurred on Bluebird Ridge Recycling and Disposal Facility. Fire response was done by site staff and the Ringle Fire Department. The fire was primary concentrated on the surface in a 100ft by 50ft area. The specific area was on the north side of Bluebird Ridge, and was the location that had been receiving "hand unload" materials from residential customers. The fire was quickly extinguished within 30 minutes of initial observation. Both soil and water were utilized in this response, and increased monitoring around this area, including gas well monitoring for temperatures, was performed. WDNR staff was notified about this event.

Cause of the fire is unknown. Cover materials in this area consisted of bark and sludge, which may have increased the chance of fire compared to a soil or ash. Fires occur quite regularly in the landfill, but operations staff are able to identify and extinguish quite easily. The majority of fire that are encountered are caused by electronic devices, specifically lithium ion batteries. Marathon County staff have worked with SWANA and AROW to better evaluate lithium ion battery fires in an attempt to move towards legislation that prohibits disposal of these items in MSW.

Fire response with additional water added after soil application.

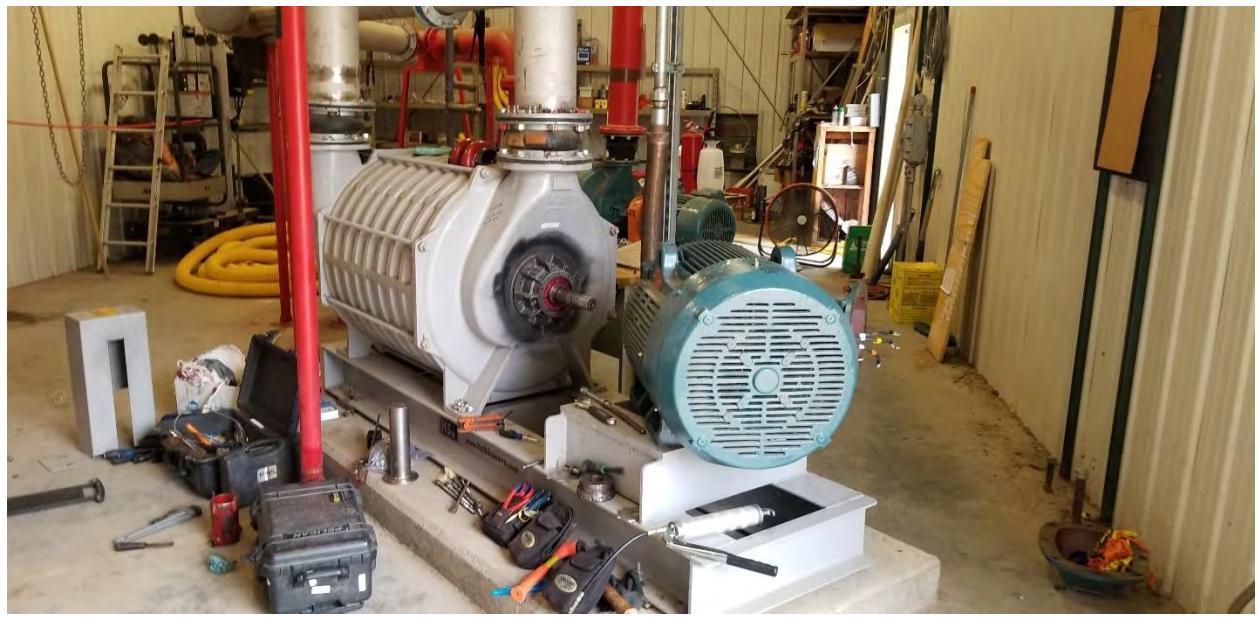
In summer of 2021, MCSWD hired Perennial Energy to do a thorough inspection and analysis on the condition of the GCCS system blower building infrastructure once again. Perennial technicians evaluated the condition of the flare, the blower, and the various valves and controls in place. The system was found to be in good working condition, but there will be necessary upgrades in the near future, including a PLC upgrade on the SCADA system. Perrenial also did blower bearing replacement in 2021.

GCCS main blower bearings replaced.

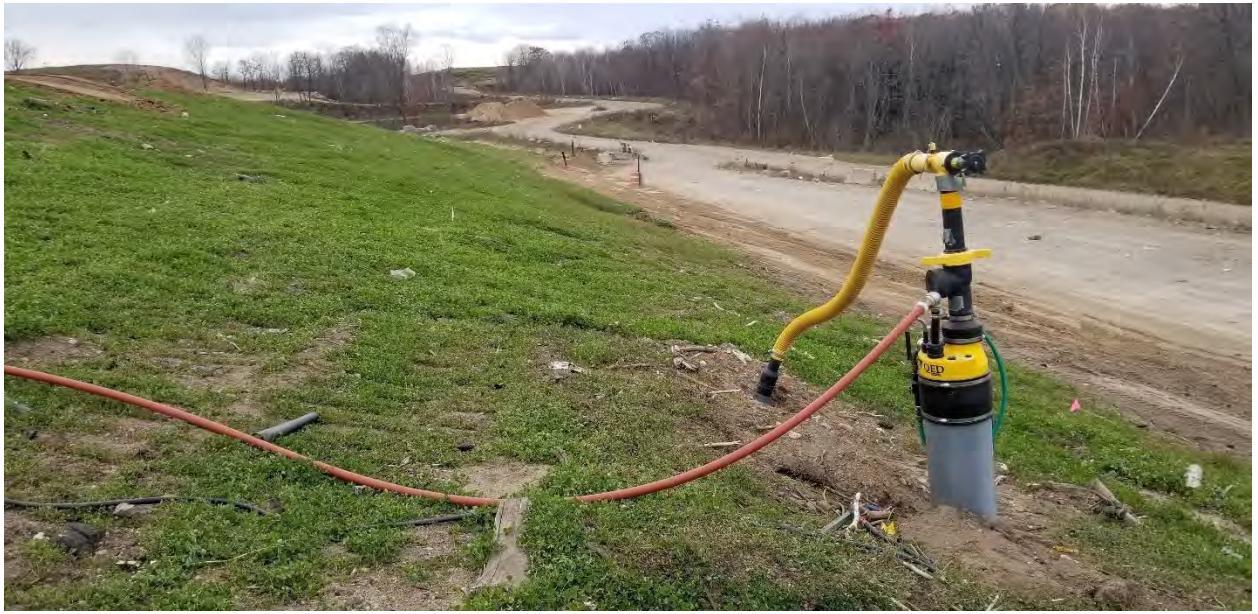
Bluebird Ridge – Gas Well 216 north side of site (pumping setup)

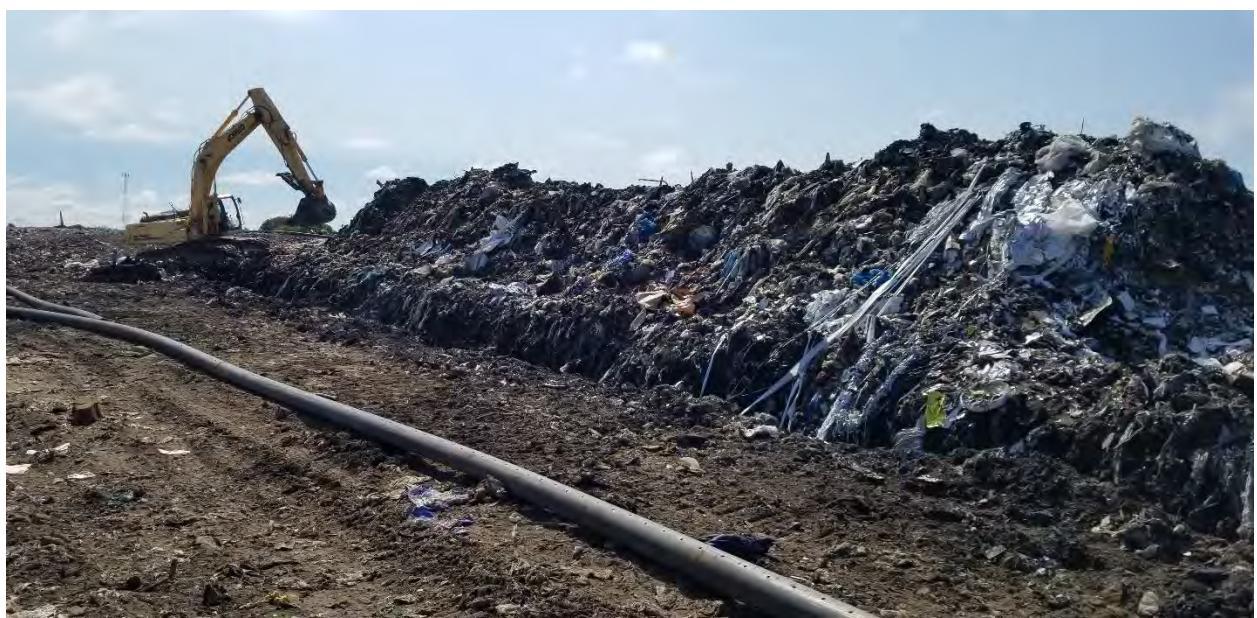
The horizontal gas collection trenches consisted of a minimum of 24 inches of coverage. The cover included 12 inches of 1-inch to 3-inch non-calcareous stone directly above SDR-17 HDPE and a minimum of 12 inches of soil backfill with geotextile located 12 inches from final grade. The construction contractor performing the installation of the LFG collection piping was Riverview Construction. Construction Quality Assurance (CQA) was performed by Tetra Tech staff and Marathon County staff, under the direction of the certifying engineer.

Horizontal collection well installation north side of BRRDF.

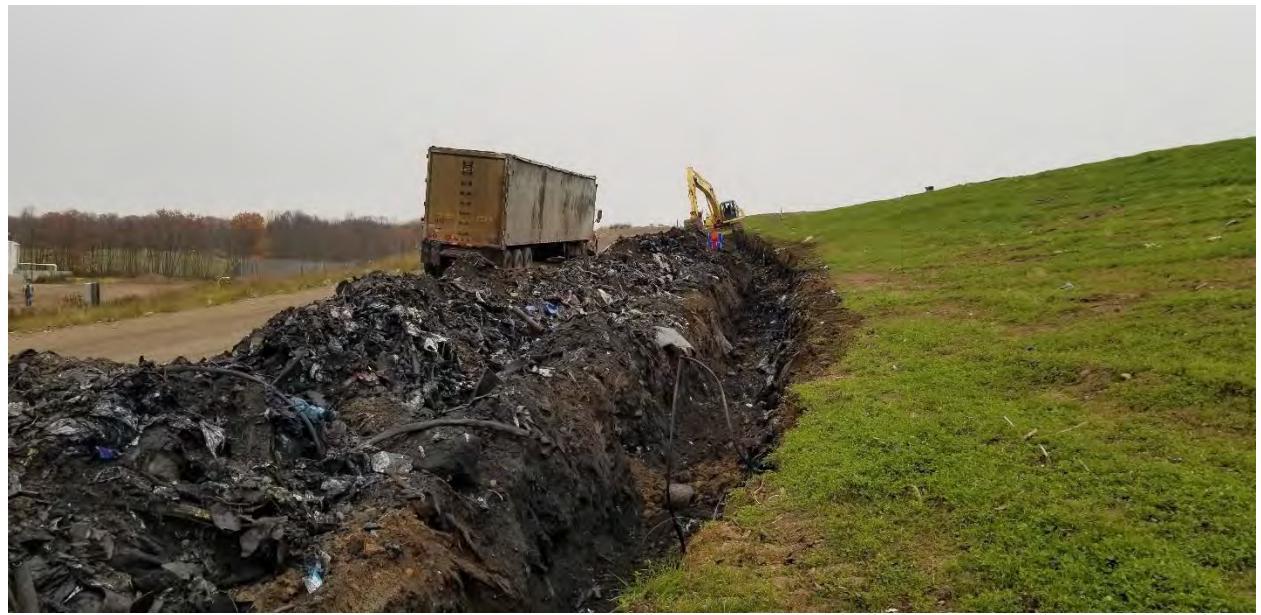
Horizontal collection well installation along access ramp – north side of BRRDF.

- Implementation of Geomembrane install on any SEM hits in addition to cover, increase in vacuum applications and bentonite
- November 2021 installation of collection well along ramp. Hook up to cleanout riser on phase 5A.

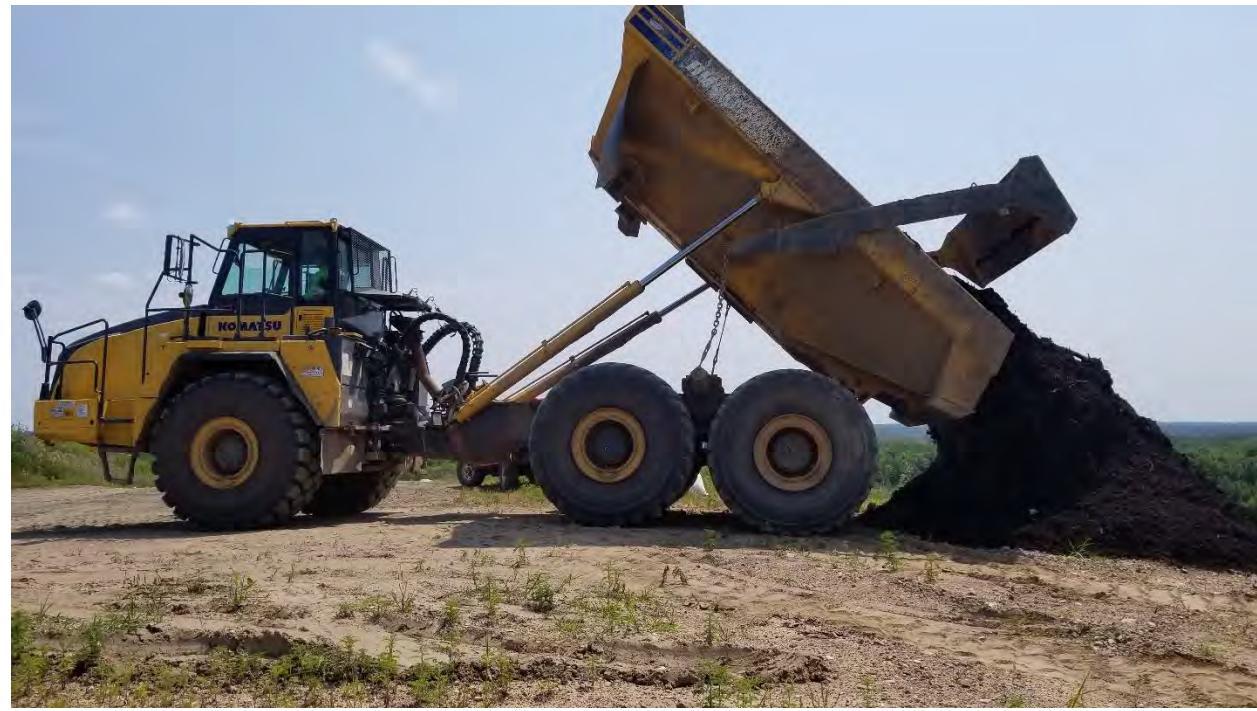
Operations of BRRDF - compost used for soil stabilization
